# Manhole Inspection Summary

Manhole # S21E1\_015MH

Insp Date: **5/22/08 9:55 AM**

**Location** Address: **2314 atlantic av**

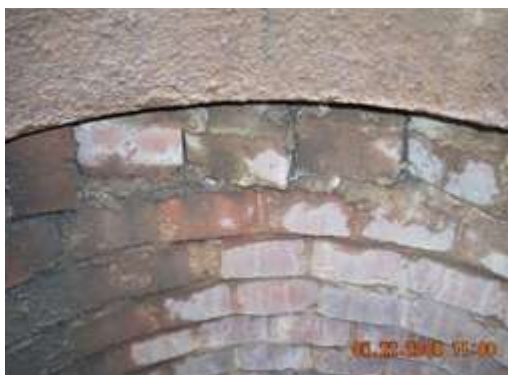
Defect 4

Condition: ☐ Sound ☐ Cracked ☐ Root Intrusion ☒ **Loose Brick** ☐ Deteriorated

loose chimney bricks

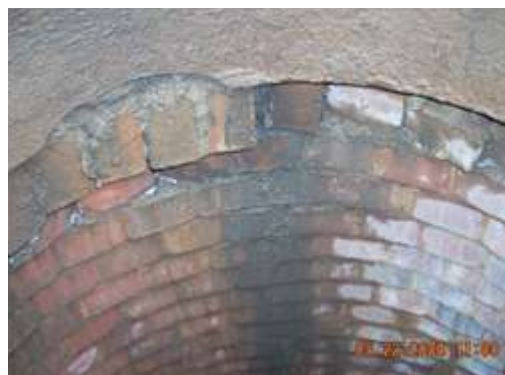
Defect 3

☒ **Cracked**

☒ **Leaks**

Infiltration: ☐ None ☒ **Joint** ☐ Cracks ☐ Mortar ☐ Roots ☐ Wall

infiltration @ chimney/frame joint, cracked frame

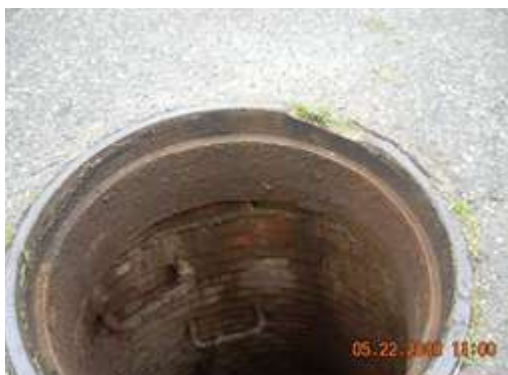
Defect 2

Subject To Ponding: **Sheeting**

inflow evidence from sheeting

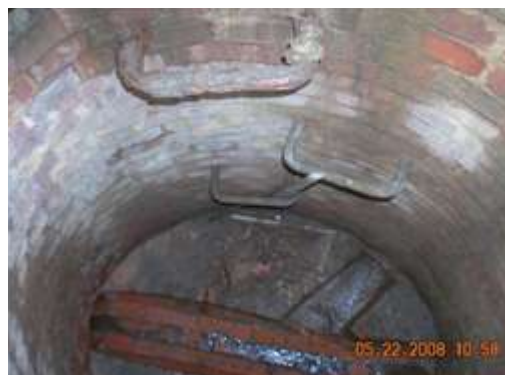
Defect 1

Count: **3** Missing: **0** ☒ **Corroded**

corroded steps

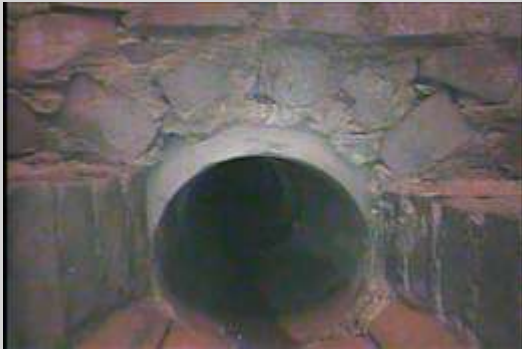
12 O'Clock Outflow

Pipe Height: **8.4** (in.) Rod and Bar (Angled)  
Pipe Material: **Clay** ☐ Pipe Lined  
Invert Depth: **6.53** (ft.) Flow Characteristics: **Slow**  
Deposits: ☒ None ☐ Mud ☐ Sludge ☐ Debris ☐ Grease  
Silt Depth: **0** (in.) Deposits Extent:  
Infiltration: **None** Pipe Seal Cond: **Sound**

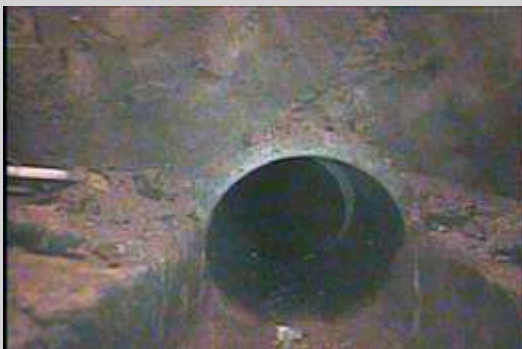
5 O'Clock Inflow

Pipe Height: **6** (in.) Rod and Bar (Angled)  
Pipe Material: **Clay** ☐ Pipe Lined  
Invert Depth: **6.09** (ft.) Flow Characteristics: **Slow**  
Deposits: ☒ None ☐ Mud ☐ Sludge ☐ Debris ☐ Grease  
Silt Depth: **0** (in.) Deposits Extent:  
Infiltration: **None** Pipe Seal Cond: **Sound**

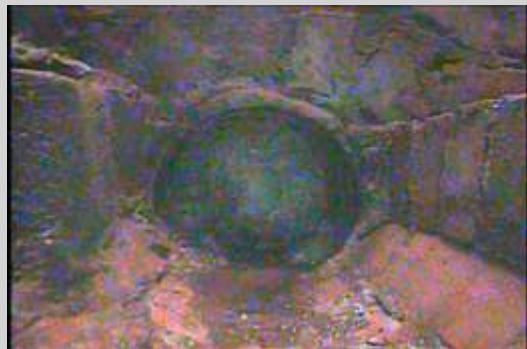
6 O'Clock Inflow

Connects To: **Stub connection / abandoned**
